# 紫外線雙面照射機

3D UV CURING MACHINE

**UVC-1014+1023ISCF**

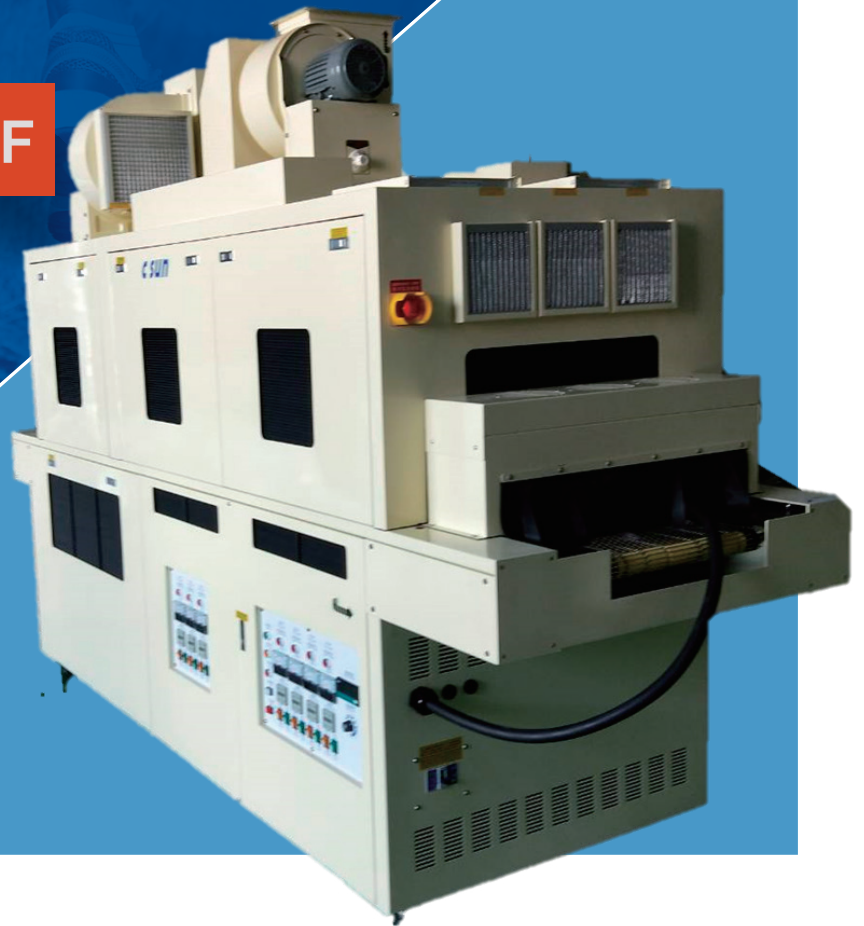
- 低溫：照射溫度  $\leq 48^{\circ}\text{C}$
- 節能：以鍍膜石英玻璃+新型氣冷方式不需冰水機就可以達到低溫效果
- 產能：800-1,000雙/小時
- 雙面照射

- Low temperature : Irradiation temperature  $\leq 48^{\circ}\text{C}$
- Energy saving: The coated quartz glass + new air cooling method can achieve low temperature effect without the need of ice chiller machine
- Capacity: 800-1,000 pairs / hour
- 3D UV irradiation with top and bottom

- 將UV處理劑擦拭於鞋材上，經UV照射乾燥後使鞋材極性增加 變得容易黏著

- Apply the UV primer on the midsole's top and bottom, after UV dried, became easy stick into.

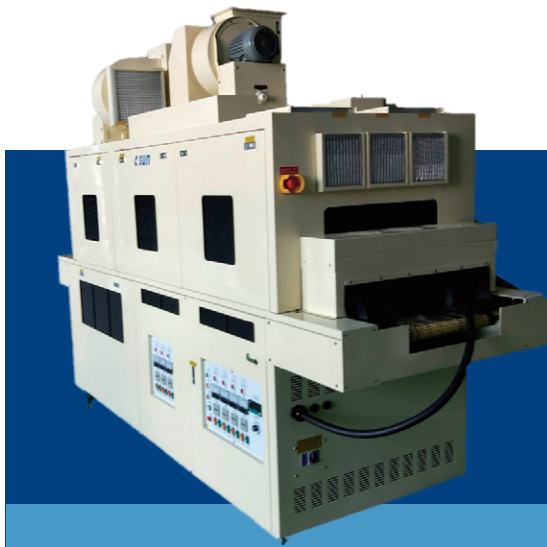
紫外線雙面照射機  
3D UV CURING MACHINE

## UVC-1014+1023ISCF

| 尺寸<br>Exterior Dimensions ( L/W/H mm ) | 有效輸送寬<br>Effective Width | 輸送速度<br>Conveyor Speed | 電力<br>Power |
| 3200 x 1020 x 2550 | 380 m/m | 3~12m/min | 24 KVA |
